Commercial Case Study & Testing Report

Aquabion UK Ltd

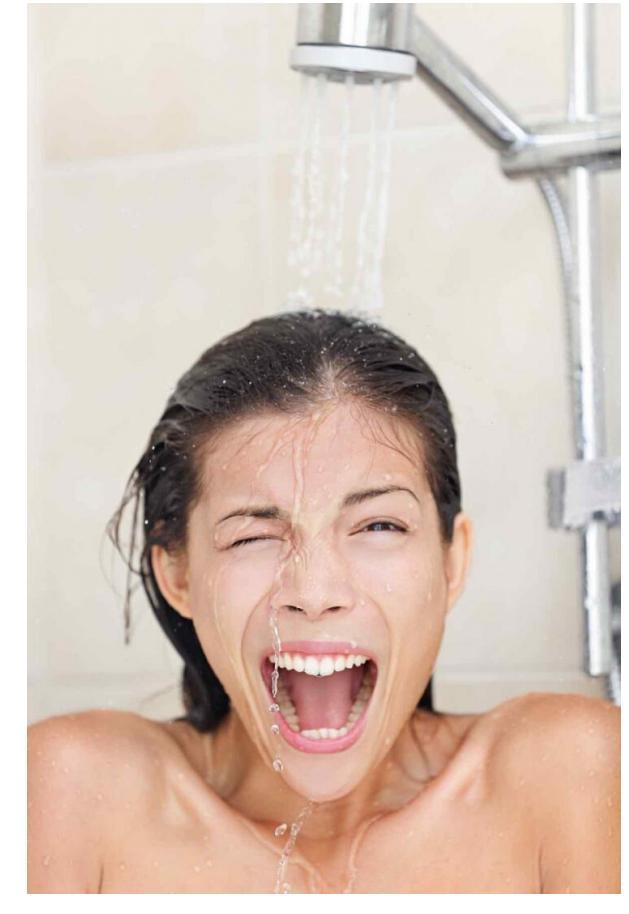
Above: Sudden premature mechanical failure of key equipment

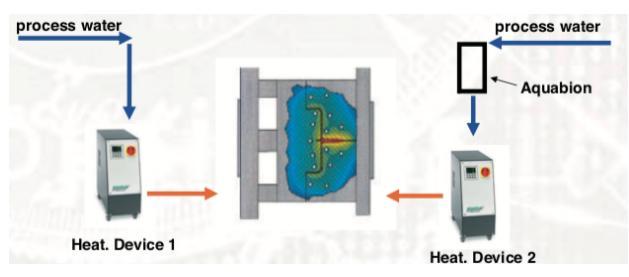
Two brand new heating devices are used to heat the injection moulding tools at the Arburg machine. Device 1 heats the ejection side, device 2, the nozzle side. The first heating device is supplied directly with process water. The Aquabion is installed between the process water supply and the second heating device.

Production is carried out with this set-up for approx. 6 months and the the heating devices are checked for limescale and corrosion.

Deposits are present on the heating rods in both heating devices. However, in the unprotected device, substantially more deposits have formed and the layers of these are also thicker.

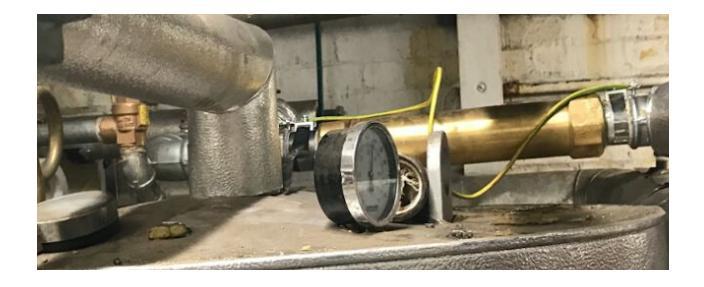
Left: One of the installed Aquabion units.

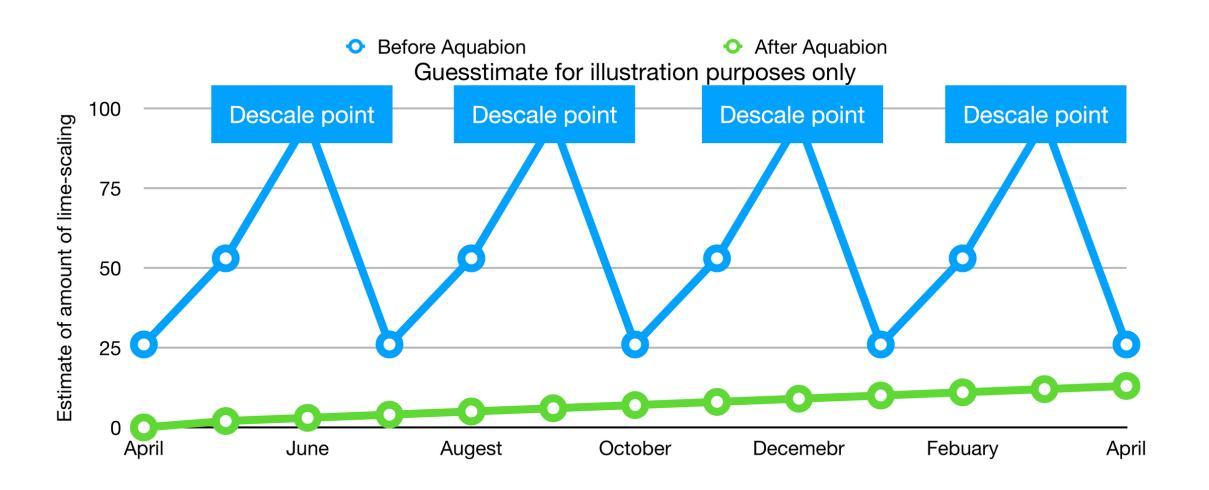
After 12 months there has not been another descale on site, saving the council hundreds of pounds a time. If the Aquabion had not been any more effective than the other installed system, then there should have been four descales in this period (see below graph for illustration purposes only). So during the 12 months following the installation of the Aquabion, the council had saved thousands and the tentants had a better quality of life.

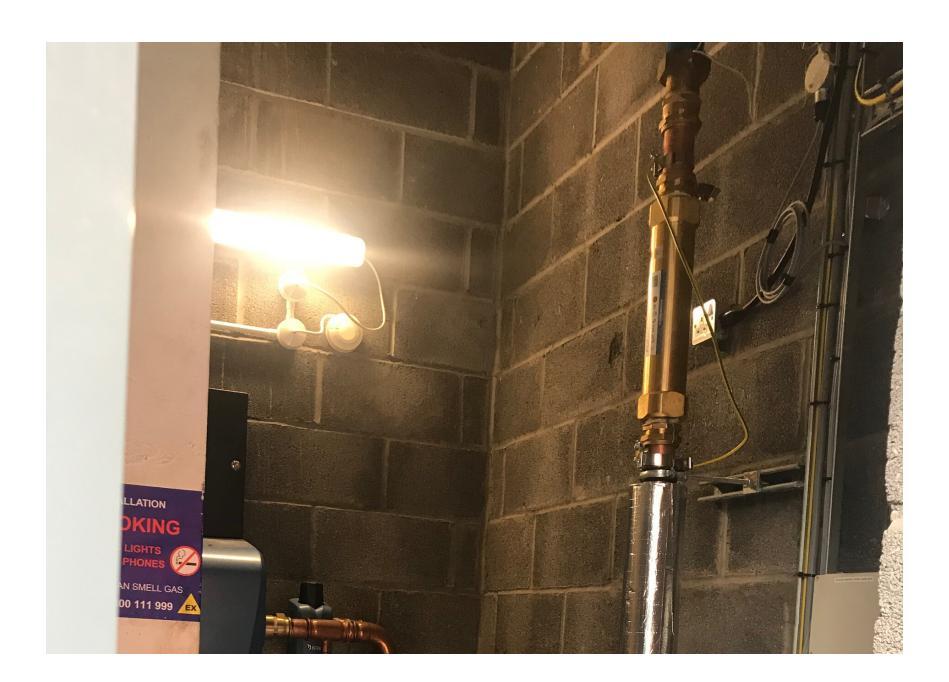
Left: The installed Aquabion in the hotel's plant room.

The installation of Aquabion units on the MCWS and the HWSR means that the unplanned de-scaling visits have been stopped in the hotel.

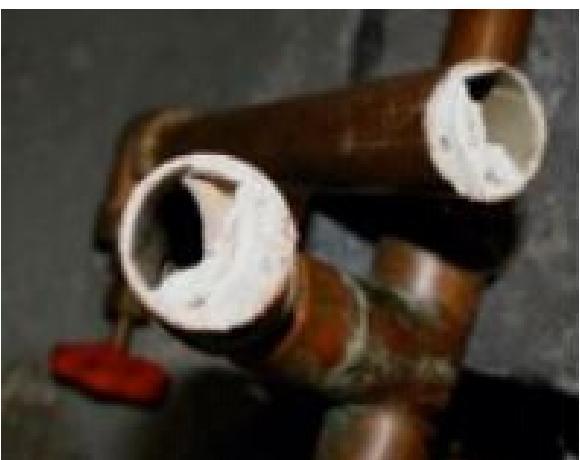
RINNAI Hot Water Heaters on this site have been known to stop working after just 6 weeks. Shower heads have needed descaling every week, this meant costly maintenance. Pipes on this site have had to be replaced regularly due to vast scale problems. In one location a 32mm pipe has been reduced by scale down to roughly the capacity of 15mm pipework.

Above: These pipes show the extent of the limescaling problem on this holiday site

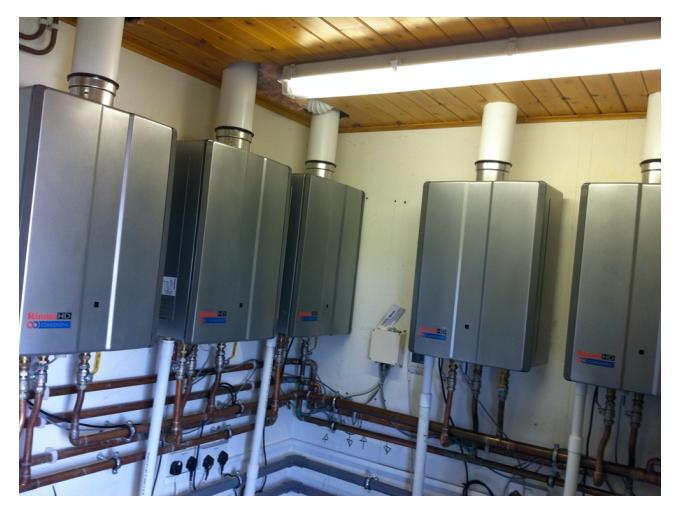
The advanced Rinnai hot water heaters have an early warning system. Once the heat exchanger starts to scale up the boiler will detect the drop in efficiency and display an error code.

Above: The advanced Rinnai hot water heaters control panels report no limescale, indicating they are running as efficiently as when they were installed.

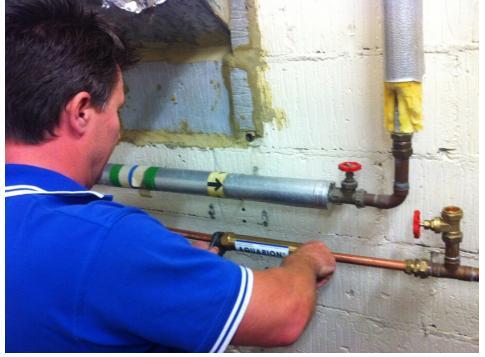
Above: Installation of the Aquabion

AQUABION[®] H20 was installed on the mains as well as an AQUABION[®] S20 on the secondary return, after the pump. This was not only supposed to provide better protection than previous technologies but also better value for money. Ron, a contractor from Metro Ltd replaced the scaled up heat exchanger, and also installed the AQUABION[®] on 16/06/11.

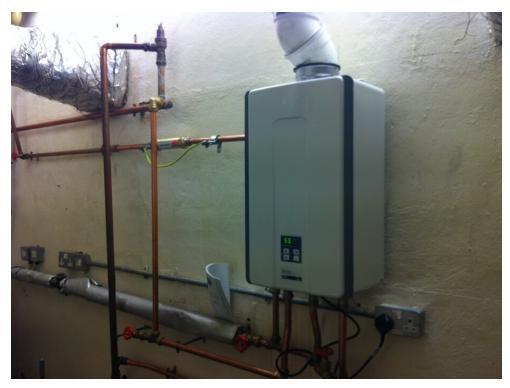
Above: The Aquabion now in place, protecting the Rinnai hot water heater
